City of Greater Geraldton  
Municipal Inventory of Heritage Places  
Place Record

| Name: | Knapp's House |
| Type of Place: | House |

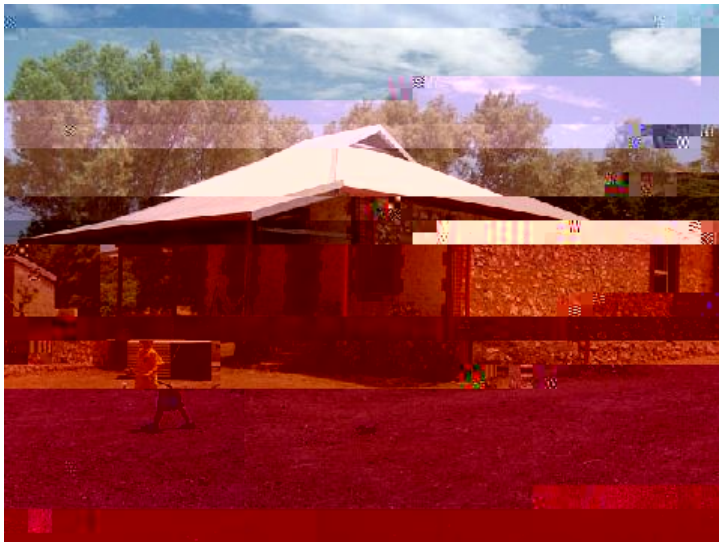
Photo Description:  
9/12/2004  
Henkel  
Front (east) elevation

Walls: Limestone                      Roof: Comugated Iron  
Condition: Fair                      Integrity:  
Original fabric:  
Modifications:

Set well of Brand Highway at the foot of the sandhills, this four-roomed stone house has a gambrel comugated iron roof which extends to cover the front (east) verandah. The house features painted random rubble stonework which is pointed to the front facade. Openings and comers are enhanced by brick quoining. Access to the house is via 5 brick steps
