City of Greater Geraldton  
Municipal Inventory of Heritage Places  
Place Record

Area: Geraldton	Place Number: 141	Category: 3
Assessment Date: 15/10/1996	Last Revision Date: 03/11/2009	
HCWA Number: 13391	Asset ID: MCH127107

Name:	House
Other Names:	83 Fitzgerald Street
Type of Place:	House
Address:	83 Fitzgerald Street
Suburb:	Geraldton

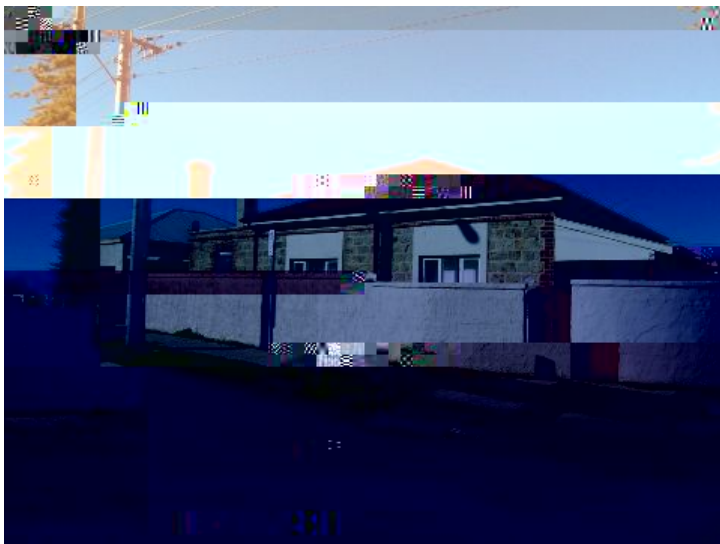
Photo Description:  
26/06/2009  
Tanya Henkel  
Stone house set behind a tall rendered wall.

Walls:	Stone	Roof:	Comugated Iron
Condition:	Good	Integrity:	
Original fabric:	Highly intact		
Modifications:	New entry door

Located on the corner of Augustus Street, this stone house has a hipped comugated iron roof with a separate verandah to the front (west) elevation which is supported on timber posts. To the rear there is a skillion roof with a tall corbelled chimney. The stonework is coursed with brick quoining to the original openings and corners of the building. The timber windows are a mixture of original double hung and casement. The house is set behind a tall rendered masonry wall which largely obscures the view to it from the street.

Management Category:	3
Level of Significance:	MODERATE SIGNIFICANCE: Important to the heritage of the locality.
Management Recommendation:	Conservation of the place is recommended. Any proposed change to the place should not unduly impact on the heritage values of the place and should retain significant fabric wherever feasible.
