City of Greater Geraldton
Municipal Inventory of Heritage Places
Place Record

Area: Geraldton	Place Number: 181	Category: 2
Assessment Date: 14/10/1996	Last Revision Date: 19/11/2009	
HCWA Number: 13278	Asset ID: MCH126868

Name:	House
Other Names:	33 Francis Street
Type of Place:	House
Address:	33 Francis Street
Suburb:	Geraldton

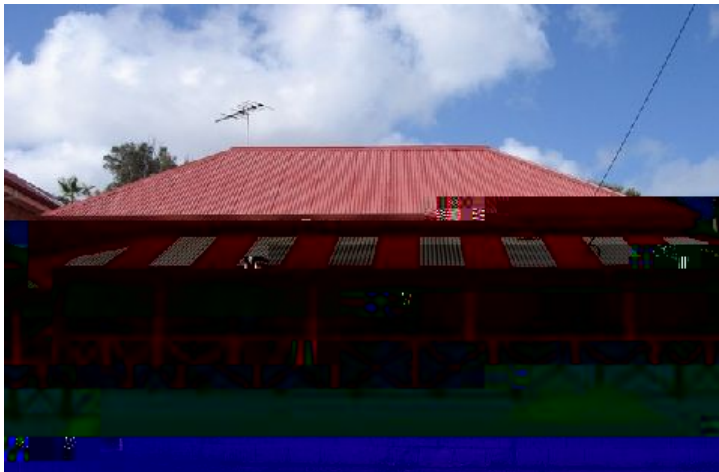
Photo Description:

French doors and criss cross balustrade to the front facade.

This rendered stone house has a hipped comugated iron roof with a lean-to roof to the rear. There is a separate hipped verandah roof to the front (west) which is supported on chamfered timber posts with a criss-cross balustrade and scalloped decoration to the south. The painted rendered stonework has an ashlar finish with contrasting paint colour to quoining around openings and comers. There are three french doors to the front verandah.vBelow ground level there is a large basement. To the south there is a new limestone block double garage.

Management Category:	2
Level of Significance:	CONSIDERABLE SIGNIFICANCE: Very important to the heritage of the locality.
Management Recommendation:	Conservation of the place is highly recommended. Any proposed change should not unduly impact on the heritage values of the place and should retain significant fabric wherever feasible.
