City of Greater Geraldton
Municipal Inventory of Heritage Places
Place Record

| Name: | House |
| Address: | 79 Gregory Street |
| Suburb: | Beachlands |

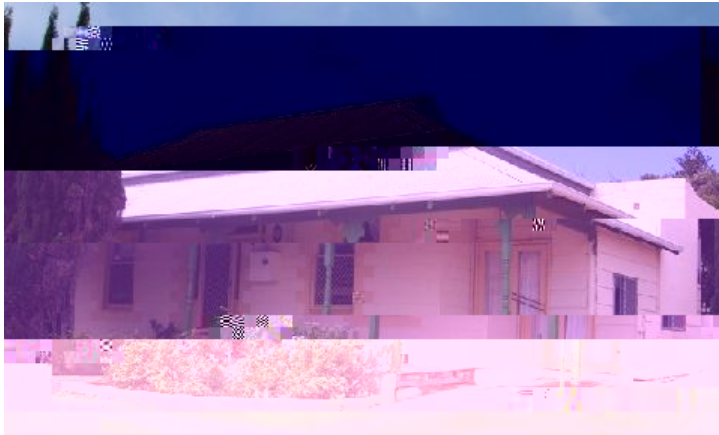
Photo Description:
14/11/2007

| Condition: | Good | Integrity: | |

Set close to the street boundary, this painted concrete block house has a comugated iron gambrel roof. A separate hipped roof covers a verandah to the front and a fibro enclosed area to the south. The front verandah is supported on tuned timber posts which have decorative fretwork brackets. The front facade has contrasting paint treatment which highlights the quoining to the doorway and windows which are timber framed and double hung.

| Management Recommendation: | Conservation of the place is recommended. Any proposed change to the place should not unduly impact on the heritage values of the place and should retain significant fabric wherever feasible. |
