City of Greater Geraldton
Municipal Inventory of Heritage Places
Place Record

| Name: | Seventh Day Adventist Church, Fmr |
| Address: | 119A Shenton Street |

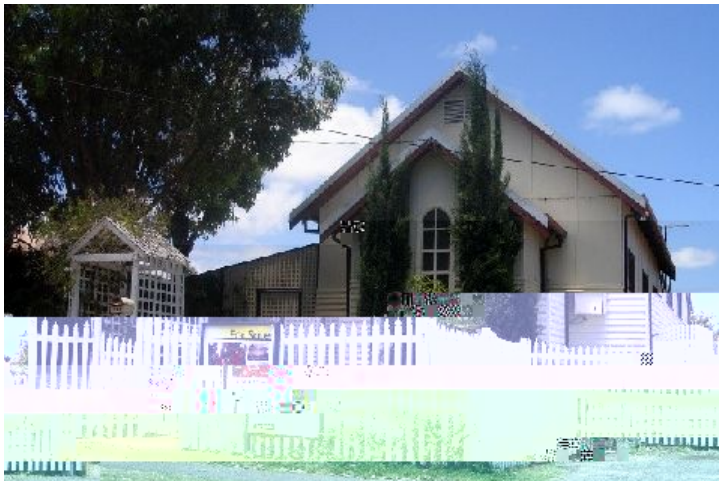
Fomer Seventh Day Adventist Church, front facade.

This former church has a steeply pitched corrugated iron gable roof with a small gable to a porch to the front elevation. The building is clad with weatherboard to half height with fibro above. The gable end has a slatted timber framed air vent. Windows to the sides are timber framed casement style. The front facade of the porch has three narrow arched timber framed windows. There is an extension to the rear built in sympathetic style. The front of the property is bounded by a picket fence which is inset to provide parking.

| Management Recommendation: | Conservation of the place is highly recommended. Any proposed change should not unduly impact on the heritage values of the place and should retain significant fabric wherever feasible. |

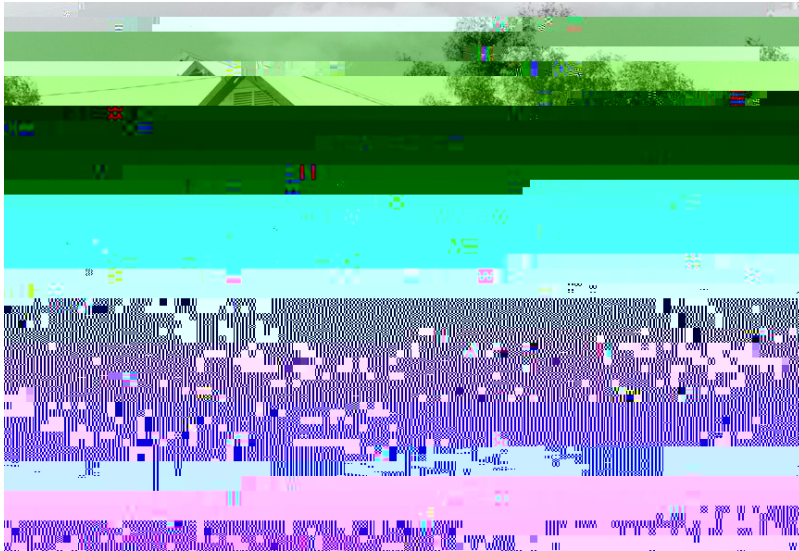
Photo Description:
24/10/1997
Suba & Grundy
Former Seventh Day Adventist Church, now a residence.
